**Federal Aviation
Administration**

ADVISORY CIRCULAR

43-16A

AVIATION MAINTENANCE ALERTS

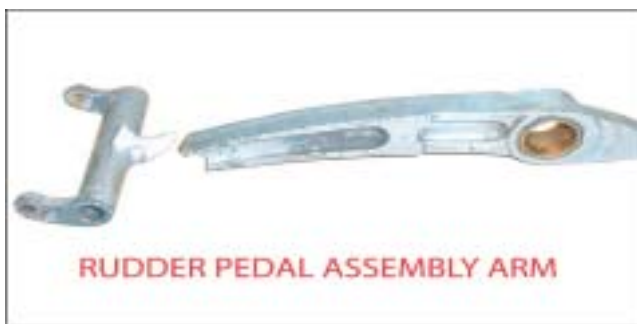
Beech; Model T-44A (C90); King Air; Cracked Rudder Pedal Arm Assembly; ATA 2720

While conducting a dye-testing inspection, the technician discovered a crack in the pilot's side right rudder pedal arm assembly (P/N 50-524326-25). He stated that the failed rudder pedal arm assembly was made of magnesium, but the replacement part was aluminum. (Refer to the illustration.)

The dye-testing inspection was performed as part of a Navy T-44A fleet-wide inspection after four rudder pedal assembly arms failed in a 3-month period. The inspections revealed 16 failures in a fleet of 54 aircraft.

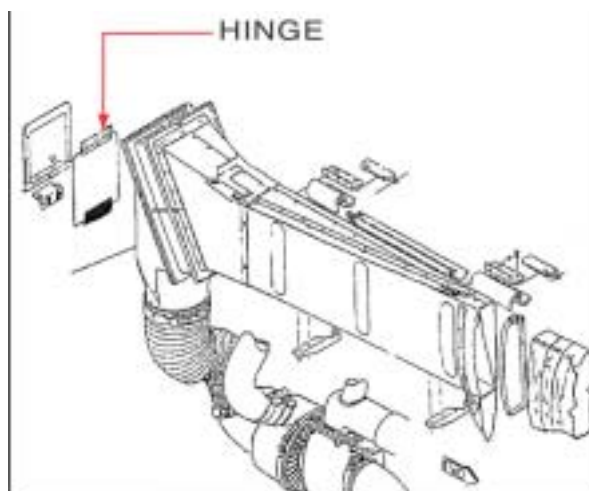
Cessna; Model T-210J; Centurion II; Failure of the Alternate Air Door Hinge Pin; ATA 7160

The submitter reported the original alternate air door hinge pin (P/N 1250839-12) was made out of aluminum. The pin had worn and dropped pieces into the intake system causing damage to the turbo charger. (Refer to the illustration.)

According to the submitter, the new hinge pin is made of stainless steel and secured in the hinge by crimping. He recommended routine inspections of this area and changing the aluminum pins to stainless steel pins.

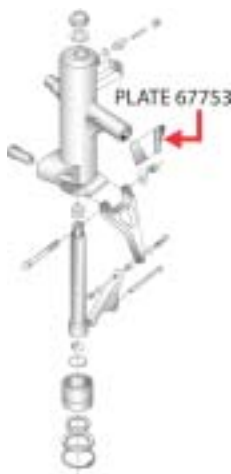
PIPER**Piper; Model PA-28R-201; Arrow III; Failure of the Main Landing Gear Down-Lock System; ATA 3230**

During a preflight walkaround, the pilot noticed the main landing gear down-lock spring (P/N 67203-00) was hanging down by one end.

Further investigation revealed the spring attach bracket (P/N 67753-000) had broken and the main gear down-lock spring was not attached to the trunnion. (Refer to the illustration.) The spring attach bracket is mounted to the trunnion underneath the squat switch and is attached by two bolts. The bracket failed at the attach point for the down-lock spring.

According to the submitter, the spring is the emergency-extension system backup if the hydraulic system fails.

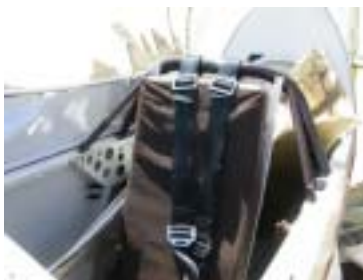
THE EFFECTS OF MODIFYING SAFETY EQUIPMENT

The standard RV-4 aircraft kit was equipped with a roll bar which was to be installed directly aft of the forward pilot's seat. The roll bar conformed closely to the inside dimensions of the canopy just aft of the forward pilot's seat and was designed to protect the forward seat occupant in the event of a rollover/nose over occurrence. The owner/builder modified the roll bar in his RV-4 aircraft from the original "elliptical" design to a shortened, inverted "U" (refer to graphic image). The top of the modified roll bar reached only to the approximate height of the pilot's shoulders rather than to the upper inside radius of the canopy.

On the evening of June 28, 2003, while the pilot was en route from Idaho to his home airstrip, the engine suffered a total loss of power and the pilot executed a forced landing to a field consisting of slightly rough terrain covered with 3 to 5 foot high grass. During the landing roll the tailwheel-equipped aircraft nosed over. Post mortem examination of the pilot revealed the cause of death as "multiple blunt force head and neck injuries" and "probably positional asphyxia as [a] contributing factor." The pilot would very likely have sustained only minor injuries had the non-modified roll bar been installed.
